# Storms on Chesil Beach

Ed Harland

Fleet Study Group

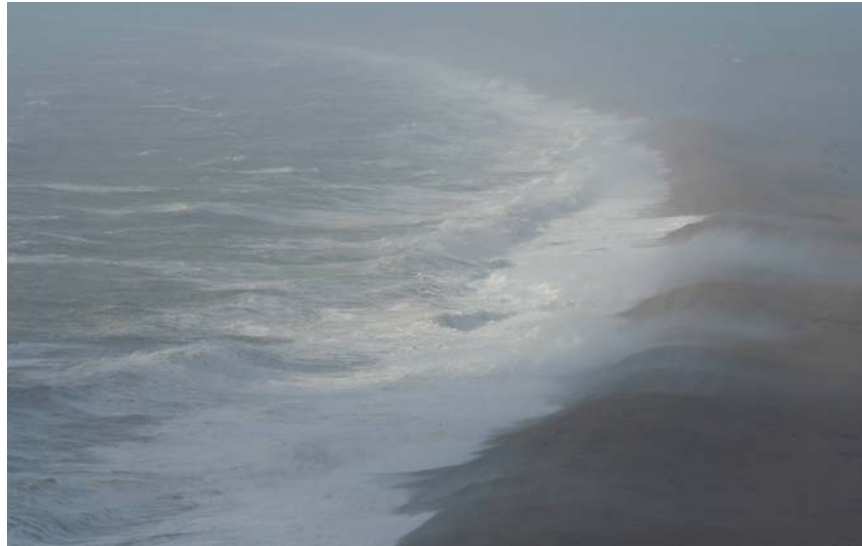
Chesil Beach has a generally south-west facing aspect and the waves arriving on the beach may have travelled from well out in the Atlantic Ocean. Under storm conditions huge swells can impact the beach and these can considerably modify the beach profile, and, in extreme conditions, can cause temporary breaches of the beach. Wave heights most winters regularly reach 6 metres during periods of gale force winds. Under extreme conditions wave heights of 15 metres and more can occur. These waves can modify the beach in a number of ways. As the wave height increases pebbles are increasingly moved around the beach. Depending on the wind speed and direction, the pebbles may be moved up or down the beach or can be moved north or south along the beach.

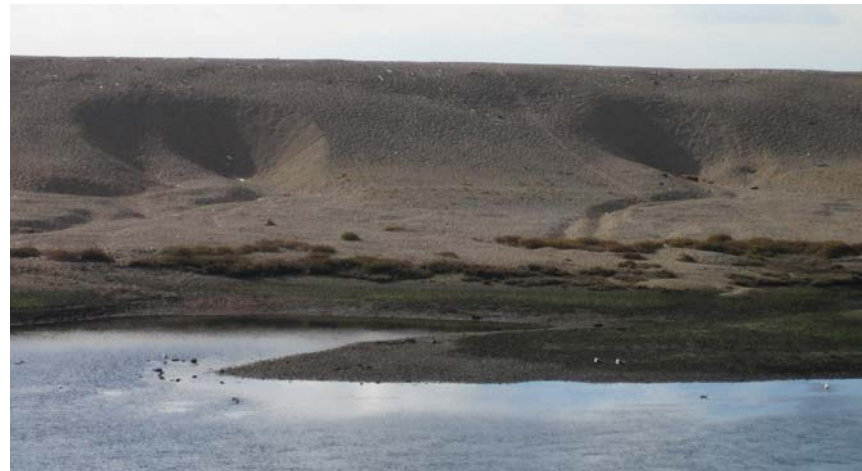
As the wave height continues to increase eventually the waves start breaking over the top of the beach and there is considerable pebble movement. This usually occurs during periods of low barometric pressure and this can result in a storm surge in the Channel raising the mean water level. As a result of both effects, a large amount of water percolates through the beach and starts pushing out pebbles on the Fleet shoreline. Volumes of pebbles can be pushed out into the Fleet leaving voids known as 'canns'. Examples of large cans can be clearly seen in the beach opposite the Wyke Bridging Camp.

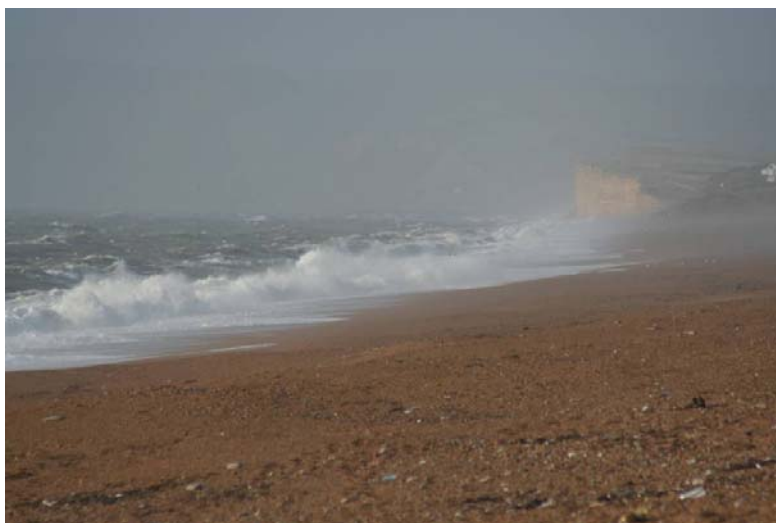
Under extreme conditions, the cann will be sufficiently large to result in a breach of the beach. This last occurred in 1990 just north of the check-point by the entrance to the WPNSA on the Portland Beach Road and the resulting flow of water washed away a portion of the beach road. It is now considered that a number of weaknesses exist within the beach and the most likely places for a breach to occur are along the Portland Beach Road and in the region adjacent to the Narrows.

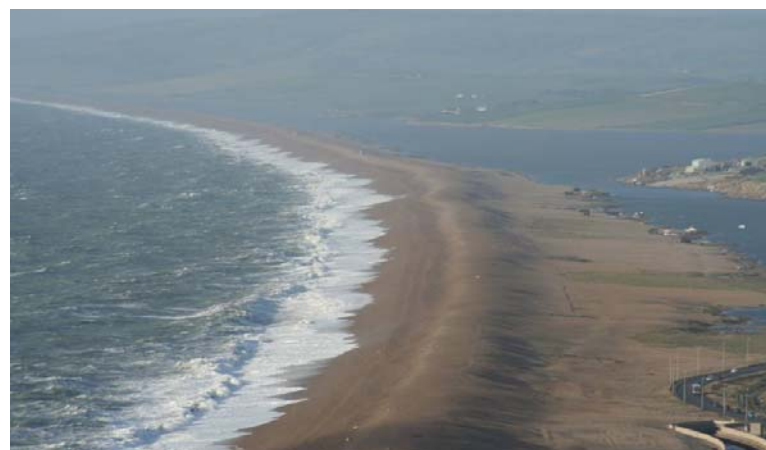
From Abbotsbury northwards, under storm conditions there can be significant erosion of the land behind the beach. This can clearly be seen at Burton Cliff, with significant cliff falls occurring.

Further south, erosion of the Fleet land shore can occur during strong current flows resulting from the build-up of water in the lagoon during storms.
